NASA TN D-5362

**EFFECT OF OUTDOOR EXPOSURE
AT ELEVATED TEMPERATURE
ON THE FATIGUE LIFE OF
Ti-8Al-1Mo-1V TITANIUM ALLOY AND
AM 350 STAINLESS STEEL SHEET**

by Edward P. Phillips

Langley Research Center

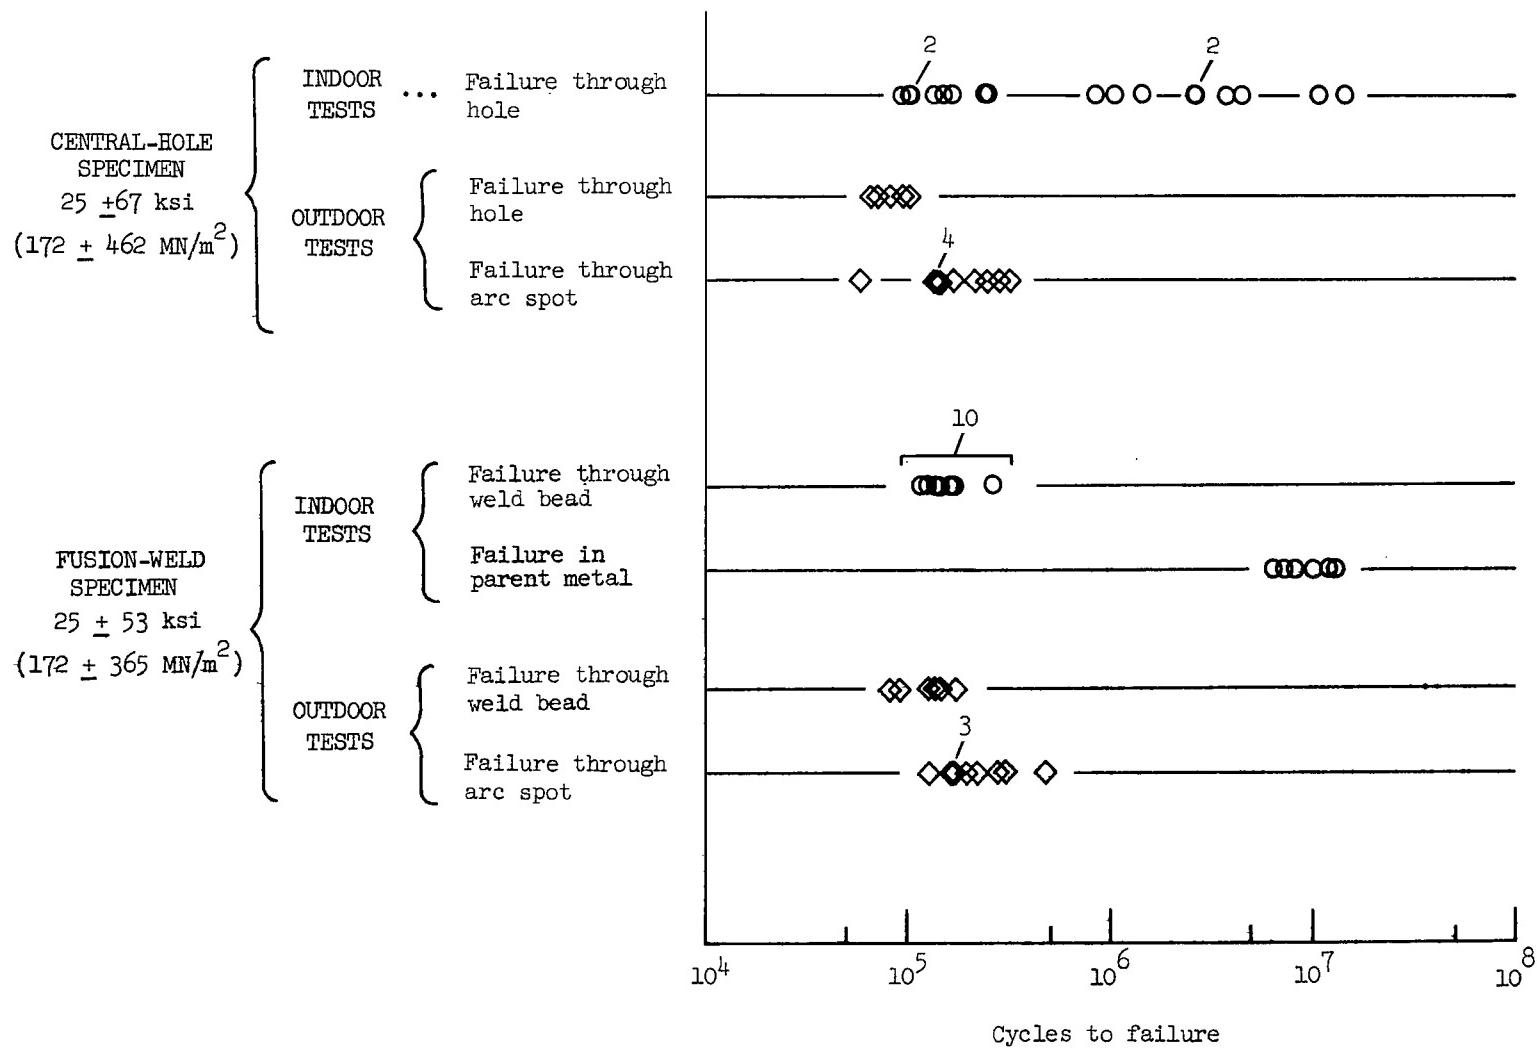
In the outdoor tests, 11 of the 16 specimens failed as a result of cracks that initiated in arc spots which were inadvertently produced on the specimens when the temperature sensors were spotwelded to the bottom surface. The arc spots were generally less than 0.01 in. (0.3 mm) in diameter and could not be detected with the unaided eye prior to the elevated-temperature exposure. During the elevated-temperature exposure, the arc spots were preferentially oxidized and discolored, and eventually were detectable with the unaided eye. The arc spots were concentrated in the area between the test section and the grip line, and consequently most of the fractures did not occur through the test section. Some failures occurred in cross sections at which the nominal stress was as low as 60 percent of that at the test section. A metallurgical examination revealed that cracking in the arc spots was related to the local metallurgical transformation and to the slight pitting of the surface which occurred. The outdoor test environment apparently was not a significant factor in the occurrence of these failures since similar failures were subsequently produced in unheated, unexposed specimens.

In the outdoor tests, specimens began failing after approximately 9 months of exposure. Although nine of the 15 specimen failures were induced by arc spots, five of the first six failures were not influenced by arc spots and initiated in the weld bead, as did the short-life failures indoors. The first failures outdoors occurred at a fatigue life approximately 3/4 of that observed for the first failures indoors. The number of cracks initiated in the outdoor tests was similar to that observed in the indoor tests.

Figure 6.- Results of indoor and outdoor fatigue tests on central-hole and fusion-welded specimens of Ti-8Al-1Mo-1V (duplex annealed) titanium alloy.

The specimen failures caused by the arc spots prevented the determination of the effects of the outdoor test environment on the median life of the sample. However, these failures may have provided useful information by indicating that titanium alloys may be unusually sensitive to such defects and that caution must be exercised when using equipment which might cause arcing near titanium alloy structures.

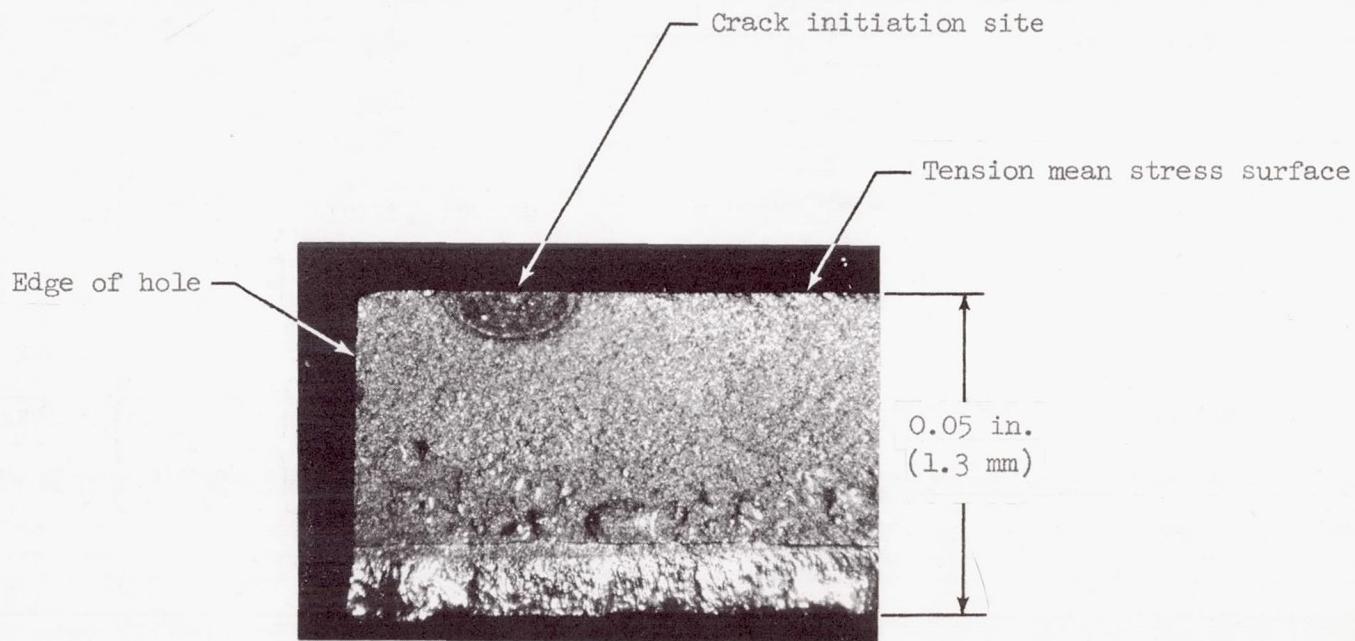
All of the specimens tested outdoors failed through the hole, as did the indoor specimens. In the outdoor specimens, however, there was a greater tendency to crack equally on each side of the hole. Also, in most of the specimens, secondary cracks initiated ahead of the main crack in slightly different cross sections. Crack initiation sites were easily identified on the outdoor specimens because of the discoloration of the fracture surface due to the elevated-temperature exposure. Examination of these specimens revealed that the cracks initiated 0.01 to 0.04 in. (0.3 to 1.0 mm) from the edge of the hole, as was noted for the indoor specimens. The location of a crack initiation site with respect to the hole is shown in the photograph of figure 7.

Figure 7.- Photograph of crack initiation site in central-hole AM 350 specimen tested outdoors.
